**Flood Control Project Maintenance
Levee Inspections**
LMA District Cover Sheet
Spring 2018 Levee Inspection Results

Marysville Levee Commission

Spring 2018 Levee Inspection Results

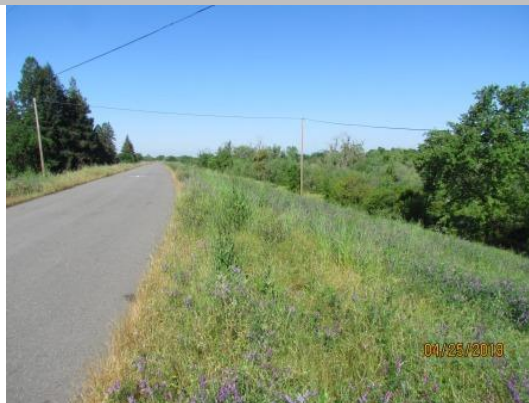
Photo 1 of 1 : SP_2018_NA0004_104_11_20180427_00020.jpg

View looking downstream waterside of the annual vegetation that needs to be maintained, Spring 2018.

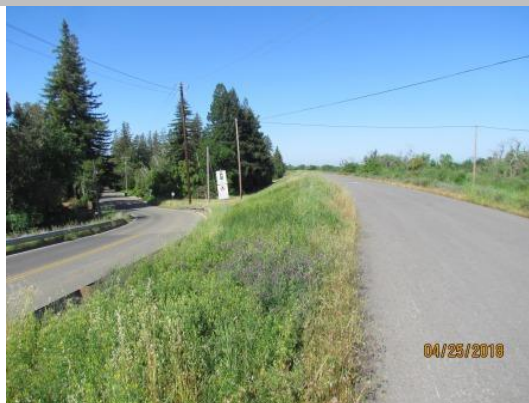
Photo 1 of 1 : SP_2018_NA0004_104_9_20180427_00021.jpg

LM Start	0.00	Rating **	M	Issue No.	9
LM End	3.15	Issue Type +	Ma	Location *	LS
Category	Earthen Levee			GPS Latitude/Longitude	
				Start	End
Item	Vegetation			39.149571 °	39.164075 °
				-121.601101 °	-121.560876 °
DWR ID	DWR_NA0004_01_s_2018_9				
Comment Code					
V1 : Control annual grass and weeds on the levee slopes and easements.					
Inspector Comment					
Annual vegetation needs to be maintained, Spring 2018.

View looking downstream landside of the annual vegetation that needs to be maintained, Spring 2018.

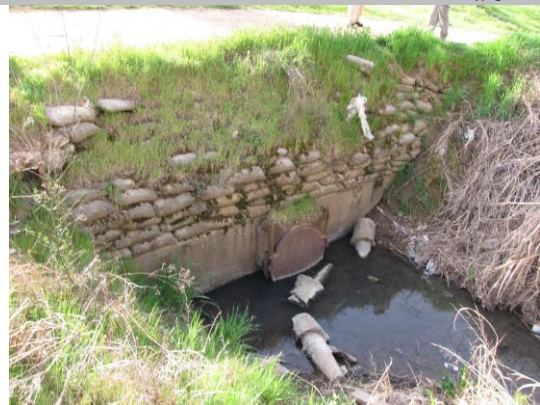
Photo 1 of 3 : UCIP_SP_2018_42945_69744.jpg

Item	DWR UCIP LMA Responsibility		39.153107 °	39.153107 °								
			-121.594835 °	-121.594835 °								
DWR ID												
Comment Code												
Inspector Comment												
FS_ID:42945 DS_ID:19090 EP_NO: N/A Repair Type: No Action Needed Crossing Status: Found UCIP Comments: FIELD_STRUCT_DESC: 36-inch corrugated metal drainage pipe through levee, 27 feet below crown. Flap gate and concrete "U" headwall on waterside (WS) end. Slide gate in 48-inch corrugated metal riser on WS slope of pipe. Steel walkway to control gate. Outfall drains from Ellis Lake. Concrete headwall at both toes. Concrete base under riser units. Steel riser unit and slide gate added under Permit No. 4041, 1962-Marysville Levee Commission. [Additional Reference(s): DWR Levee Logs, 1993 and 2005. USACE Sacramento O&M Manual Unit No. 147, August 1955, (Station 8+48)] FS Date: 3/14/2013

View of outlet located on waterward side under toe road.

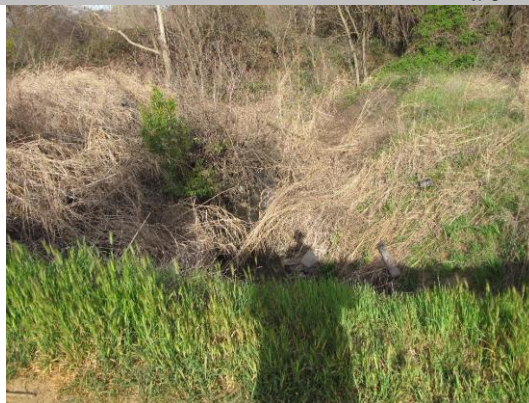
Photo 2 of 3 : UCIP_SP_2018_42945_69743.jpg

View of waterward side from toe road.

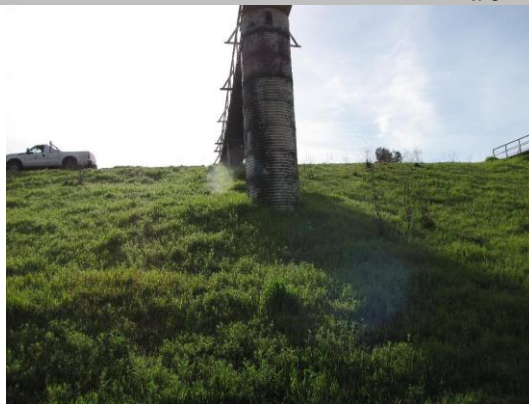
Photo 3 of 3 : UCIP_SP_2018_42945_69742.jpg

View of waterward slope.

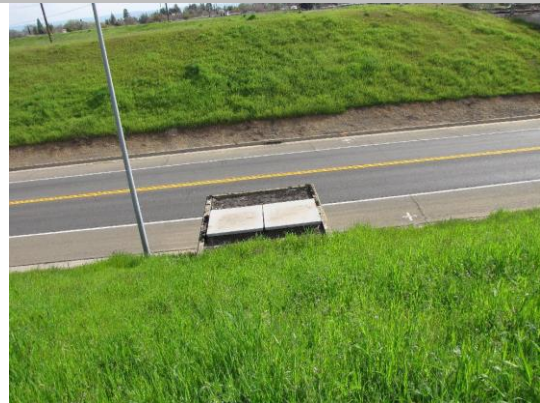
Photo 1 of 3 : UCIP_SP_2018_40931_69758.jpg

Comment Code						
Inspector Comment						
FS_ID:40931 DS_ID:19100 EP_NO: 14518 Repair Type: Non-Urgent Crossing Status: Indicator Found UCIP Comments: Recommend having owner removing tall grass along slopes to properly inspect signs of pipe failure. FIELD_STRUCT_DESC: 1 of 2: 10-inch steel drainage pipe through levee, 4 feet below crown. Flap gate on waterside (WS) end. Concrete vault on WS shoulder. Metal meter box on the landside (LS) shoulder. Pump placed on concrete footings at toe of LS slope. Drainage for underpass. Pipes approximately 2.5-feet apart. (10-inch pipe removed and replaced with new 10-inch pipe authorized under Permit No. 14518, 1987-State Department of Transportation). [Additional Reference(s): DWR Levee Logs, 1993 and 2005] FS Date: 3/14/2013

View of landward side.

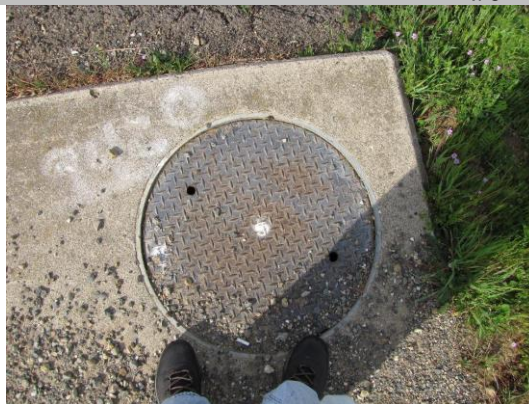
Photo 3 of 3 : UCIP_SP_2018_40931_69756.jpg

Close up view of manhole.

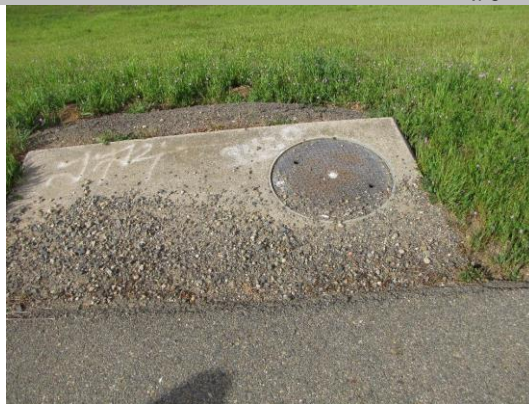
Photo 2 of 3 : UCIP_SP_2018_40933_69761.jpg

Concrete vault located on waterward shoulder.

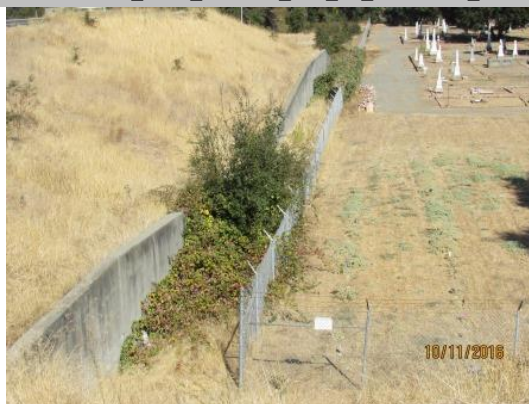
Photo 1 of 1 : SP_2018_NA0004_104_36_20180302_00007.jpg

LM Start	0.97	Rating **	M	Issue No.	36
LM End	1.19	Issue Type +	Ob	Location *	WS
Category	Earthen Levee			GPS Latitude/Longitude	
				Start	End
Item	Encroachments			39.159210 °	39.161576 °
				-121.590033 °	-121.590721 °
DWR ID	DWR_NA0004_01_f_2013_36				
Comment Code					
RW : Retaining Wall					
Inspector Comment					
Concrete retaining wall cut into levee toe, no permit found.

View of the concrete retaining wall at the toe of the levee on the waterward side looking downstream.

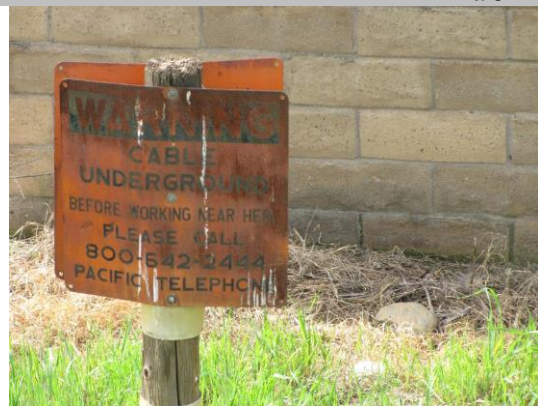
Photo 1 of 3 : UCIP_SP_2018_40935_69766.jpg

Comment Code					
Inspector Comment					
FS_ID:40935 DS_ID:19115 EP_NO: 12878 Repair Type: Non-Urgent Crossing Status: Indicator Found UCIP Comments: Need to contact owner to determine additional information about crossing and alignment. FIELD_STRUCT_DESC: 24-inch steel pipe encasing 4-inch polyvinyl chloride (PVC) communications extension through the levee, annular gap grouted, 8 feet below levee crown. Cutoff wall (12x12x20-inch) around extension from levee slopes. (underground communication extension authorized under Permit No. 12878, 1980-Pacific Telephone and Telegraph Company). [Additional Reference(s): DWR Levee Logs, 1993 and 2005] FS Date: 3/14/2013

Marker on landward side.

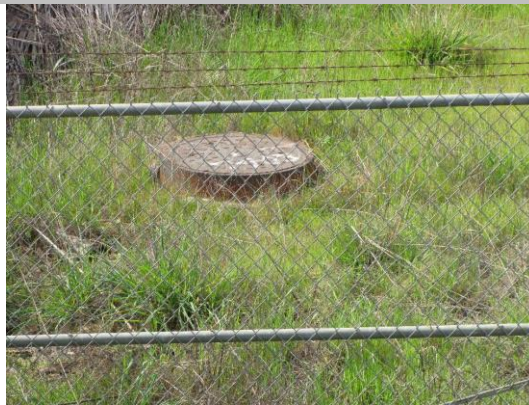
Photo 3 of 3 : UCIP_SP_2018_40935_69764.jpg

Manhole located behind fenced area on landward side.

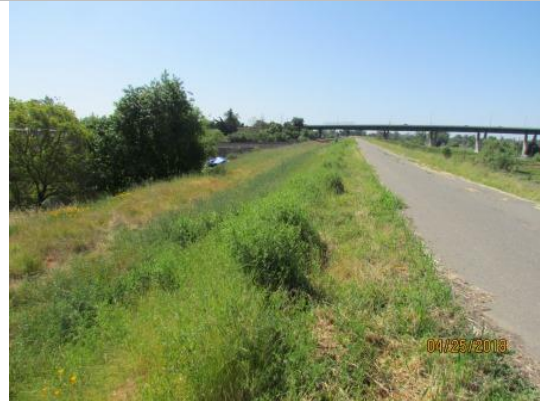
Photo 1 of 1 : SP_2018_NA0004_105_3_20180427_00013.jpg

View looking downstream landside of the annual vegetation that needs to be maintained, Spring 2018.

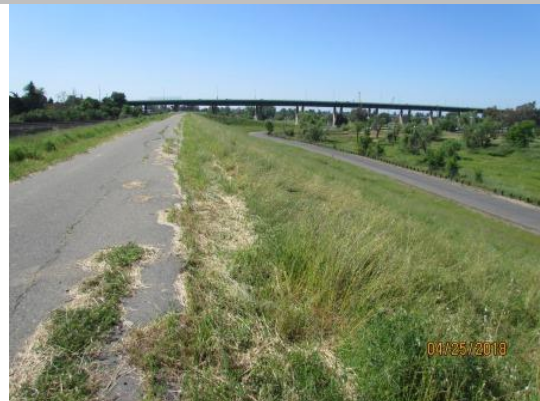
Photo 1 of 1 : SP_2018_NA0004_105_5_20180427_00012.jpg

View looking downstream waterside of the annual vegetation that needs to be maintained, Spring 2018.

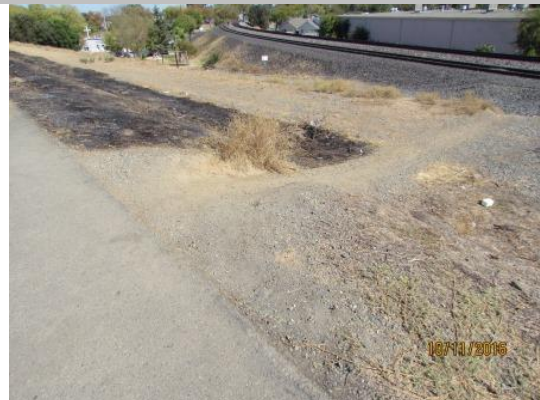
Photo 1 of 1 : SP_2018_NA0004_105_8_20180302_00003.jpg

LM Start	0.22	Rating **	M	Issue No.	8
LM End	0.22	Issue Type +	Ma	Location *	LS
Category	Earthen Levee			GPS Latitude/Longitude	
				Start	End
Item	Slope Stability			39.146352 °	39.146352 °
				-121.600724 °	-121.600724 °
DWR ID	DWR_NA0004_02_f_2016_8				
Comment Code					
S2 : Repair the levee slope damaged by foot traffic and prevent access where possible.					
Inspector Comment					
Foot path depression in the landside levee slope needs to be repaired. Fall 2016.

View of foot path depression in the landside levee slope.

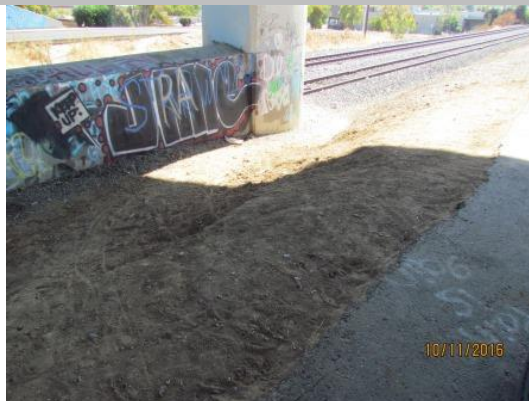
Photo 1 of 1 : SP_2018_NA0004_105_4_20180302_00001.jpg

LM Start	0.32	Rating **	A/W	Issue No.	4
LM End	0.32	Issue Type +	Ma	Location *	LS
Category	Earthen Levee			GPS Latitude/Longitude	
				Start	End
Item	Slope Stability			39.144840 °	39.144840 °
				-121.600559 °	-121.600559 °
DWR ID	DWR_NA0004_02_s_2016_4				
Comment Code					
S2 : Repair the levee slope damaged by foot traffic and prevent access where possible.					
Inspector Comment					
Foot path depression in the landside levee slope has been repaired, Spring 2017.

View looking downstream of landside slope erosion due to heavy foot traffic. Fall 2016. For Spring 2017 the foot path depression in the landside levee slope has been repaired.

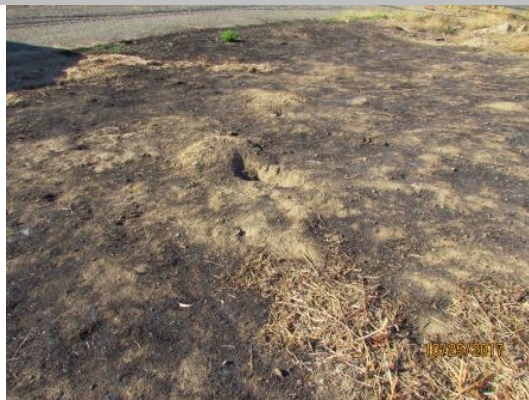
Photo 1 of 1 : SP_2018_NA0004_105_6_20180302_00002.jpg

View of landside of rodent holes, no animal activity was observed, Fall 2017.

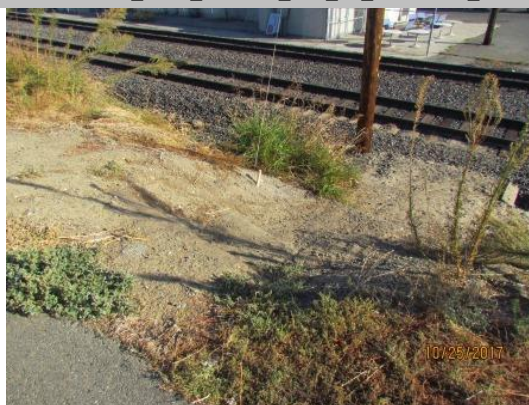
Photo 1 of 1 : SP_2018_NA0004_105_14_20180302_00005.jpg

LM Start	0.85	Rating **	M	Issue No.	14
LM End	0.85	Issue Type +	Ma	Location *	LS
Category	Earthen Levee			GPS Latitude/Longitude	
				Start	End
Item	Slope Stability			39.138463 °	39.138463 °
				-121.599168 °	-121.599168 °
DWR ID	DWR_NA0004_02_f_2016_14				
Comment Code					
S2 : Repair the levee slope damaged by foot traffic and prevent access where possible.					
Inspector Comment					
Remove steps that are cut into levee slope, Fall 2017.

View of steps for foot path in the landside levee slope, Fall 2017.

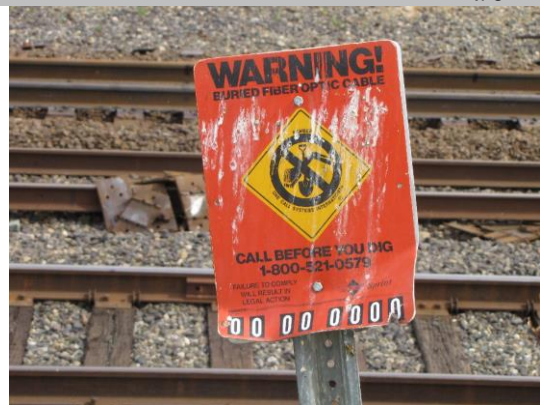
Photo 2 of 3 : UCIP_SP_2018_40940_69801.jpg

LM Start	0.87	Rating **	M	Issue No.	16	
LM End	0.87	Issue Type +	En	Location *		
Category	Supplemental			GPS Latitude/Longitude		
				Start	End	
Item	DWR UCIP Field Study			39.138269 °	39.138269 °	
				-121.599004 °	-121.599004 °	
DWR ID						
Comment Code						
Inspector Comment						
FS_ID:40940						
DS_ID:19123						
EP_NO: N/A						
Repair Type: Non-Urgent						
Crossing Status: Indicator Found						
UCIP Comments: Unable to tell if crossing goes through levee; according to Frank Miller crossing does not cross levee. Need to contact owner to confirm alignment.						
FIELD_STRUCT_DESC: Fiber optics communication line of unknown material through levee at an unknown depth below the crown. Marker on waterside (WS) shoulder. [Additional Reference(s): DWR Levee Logs, 1993 and 2005]						
FS Date: 3/15/2013

Buried fiber optical cable marker with contact information located on landward shoulder.

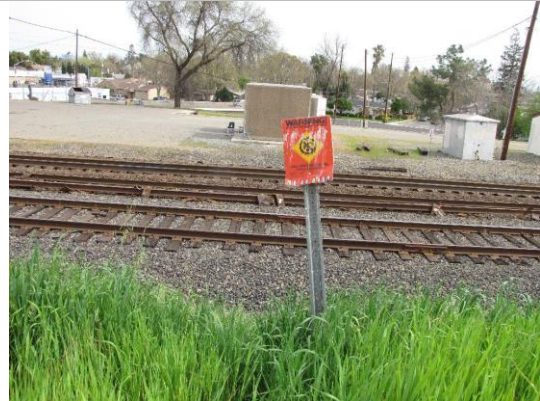
Photo 3 of 3 : UCIP_SP_2018_40940_69800.jpg

View of landward side with bldg that could be associated with cable line.

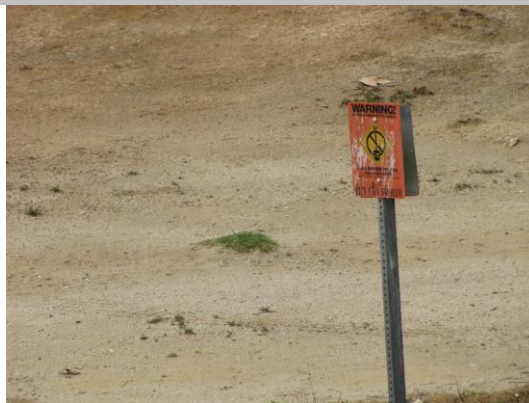
LM Start	0.91	Rating **	M	Issue No.	17	
LM End	0.91	Issue Type +	En	Location *		
Category	Supplemental			GPS Latitude/Longitude		
				Start	End	
Item	DWR UCIP Field Study			39.137749 °	39.137749 °	
				-121.598560 °	-121.598560 °	
DWR ID						
Comment Code						
Inspector Comment						
FS_ID:38272						
DS_ID:19104						
EP_NO: N/A						
Repair Type: Non-Urgent						
Crossing Status: Indicator Found						
UCIP Comments: Unable to tell if crossing goes through levee. Need to contact owner to confirm alignment.						
FIELD_STRUCT_DESC: 12-inch high-density polyethylene (HDPE) conduit, with electrical lines, through the levee at an unknown depth through the levee. Extends to controller cabinet within the overflow area.						
FS Date: 3/15/2013

View of markers located on waterward toe.

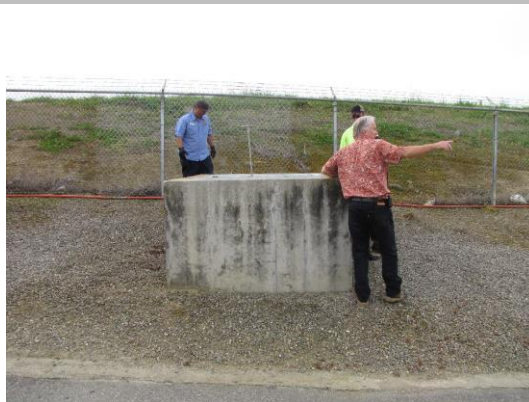
Photo 2 of 2 : UCIP_SP_2018_41024_72680.jpg

View of concrete box located on landward side--crossing not in use according to Marysville Sewage Treatment Plant Manager.

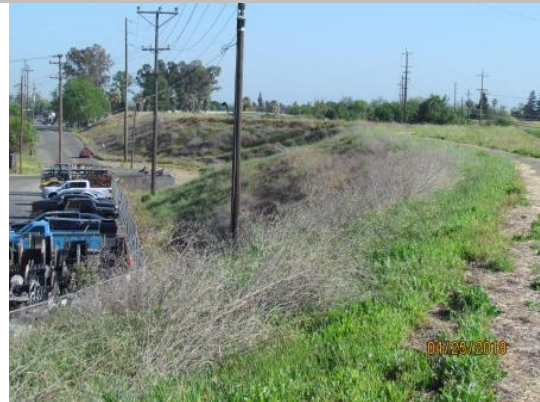
Photo 1 of 1 : SP_2018_NA0004_106_17_20180427_00046.jpg

View looking downstream waterside of the annual vegetation that needs to be maintained, Spring 2018.

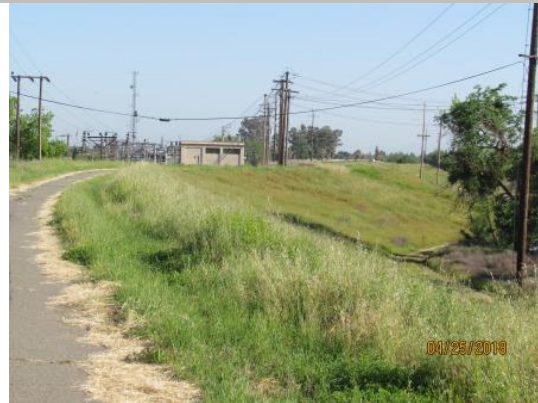
Photo 1 of 1 : SP_2018_NA0004_106_19_20180427_00047.jpg

View looking upstream waterside of the annual vegetation that needs to be maintained, Spring 2018.

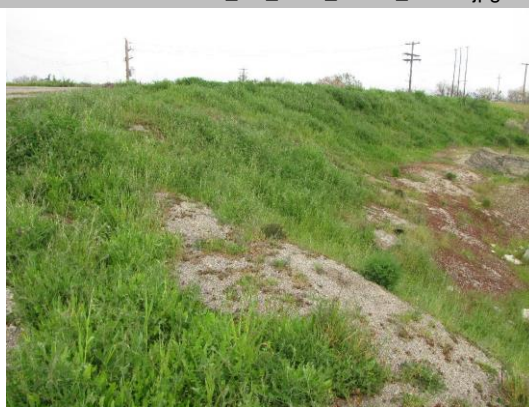
Photo 2 of 2 : UCIP_SP_2018_40969_72682.jpg

View of waterward slope--unable to confirm if crossing is active--line buried.

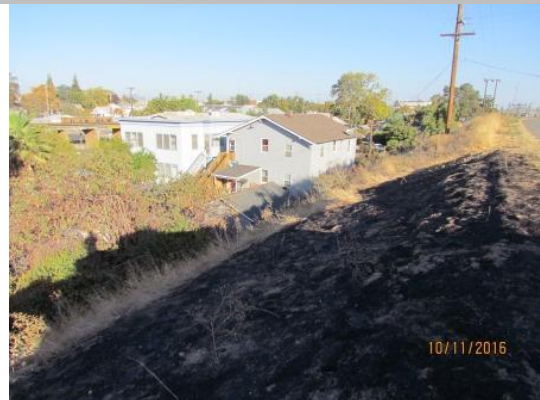
Photo 1 of 1 : SP_2018_NA0004_106_25_20180302_00007.jpg

View of House and shed at the landside levee toe looking upstream.

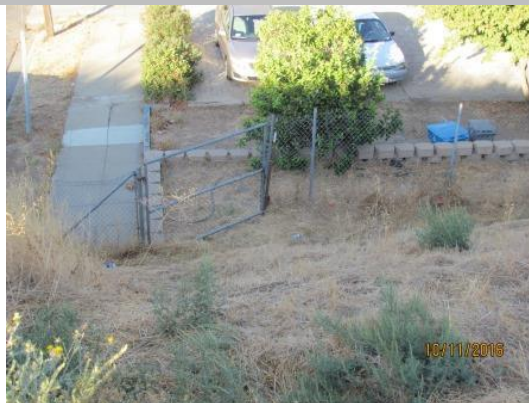
Photo 1 of 1 : SP_2018_NA0004_106_26_20180302_00008.jpg

View of fence that runs along landside levee toe.

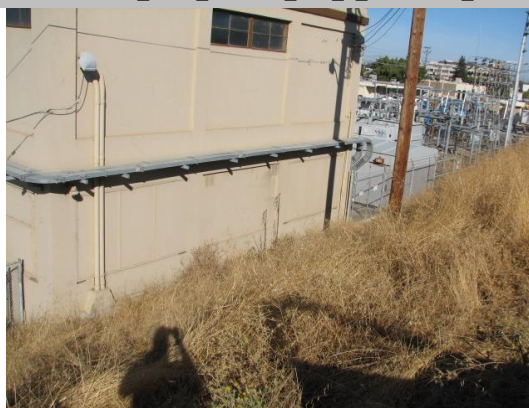
Photo 1 of 1 : SP_2018_NA0004_106_4_20180302_00003.jpg

Building encroaching at landside levee toe.

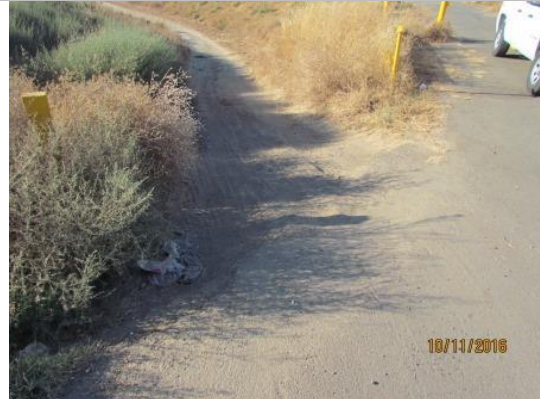
Photo 1 of 1 : SP_2018_NA0004_106_32_20180302_00010.jpg

View of ruts cut in by vehicle traffic on the waterside slope.

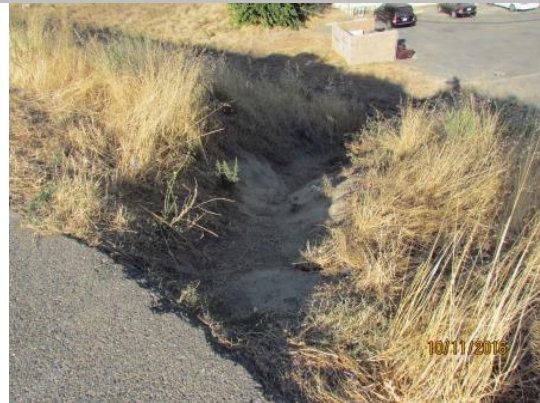
Photo 1 of 1 : SP_2018_NA0004_106_33_20180302_00011.jpg

View of path cut in by foot traffic on the landside slope that needs repaired.

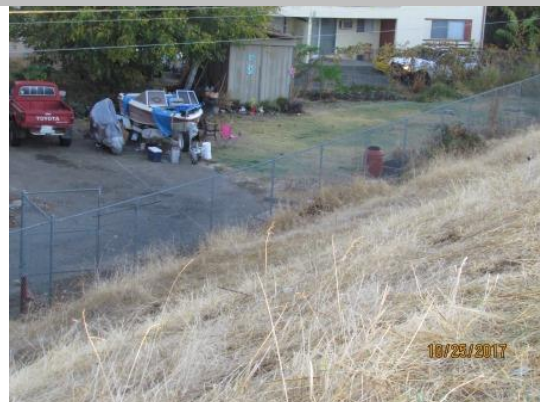
Photo 1 of 2 : SP_2018_NA0004_106_35_20180302_00012.jpg

View of fence on the landside toe, Fall 2017.

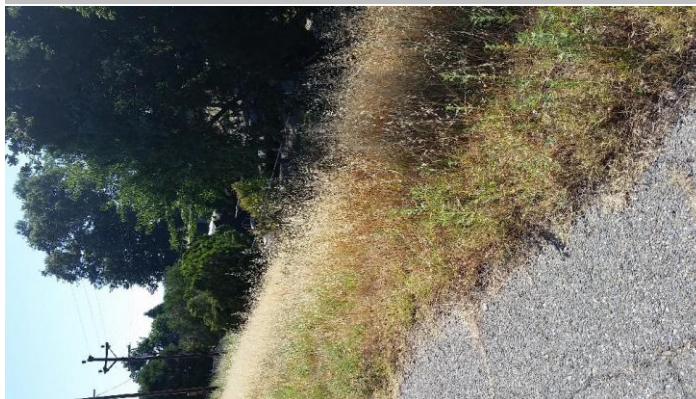
Photo 2 of 3 : UCIP_SP_2018_49951_75778.jpg

View of WS--dense vegetation on slope.

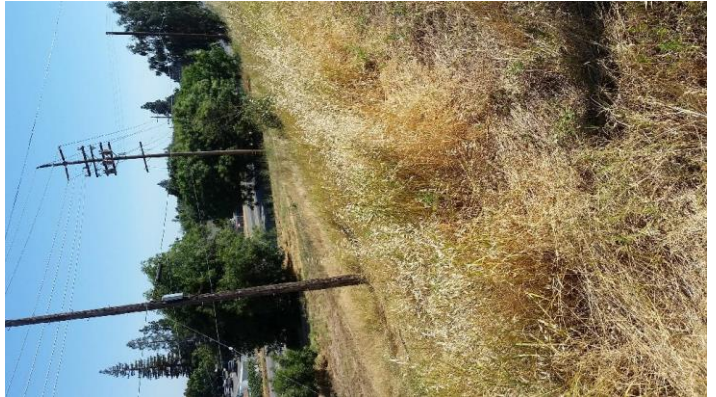
Photo 3 of 3 : UCIP_SP_2018_49951_75779.jpg

View of LS--dense vegetation on slope.

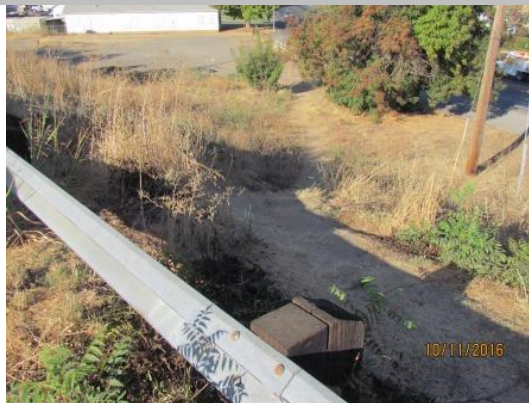
Photo 1 of 1 : SP_2018_NA0004_106_18_20180302_00006.jpg

View of foot path that has cut into landside levee slope.

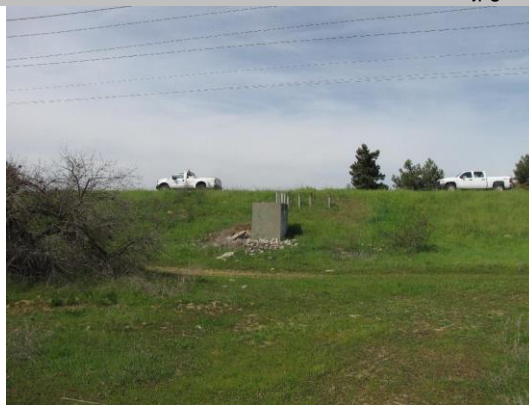
Photo 2 of 3 : UCIP_SP_2018_40999_69829.jpg

View of waterward side--concrete box and vent pipes located on waterward slope.

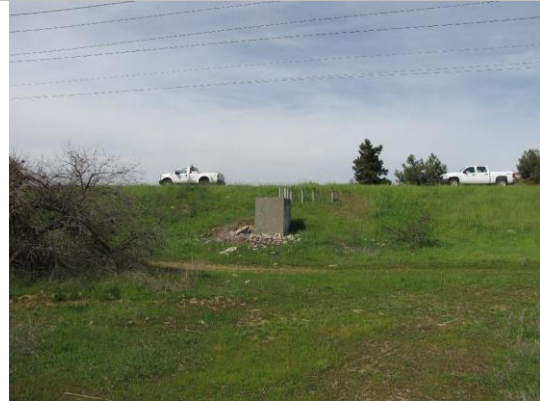
Photo 3 of 3 : UCIP_SP_2018_41001_69820.jpg

View of waterward side--concrete distribution box and gate stems located on waterward slope.

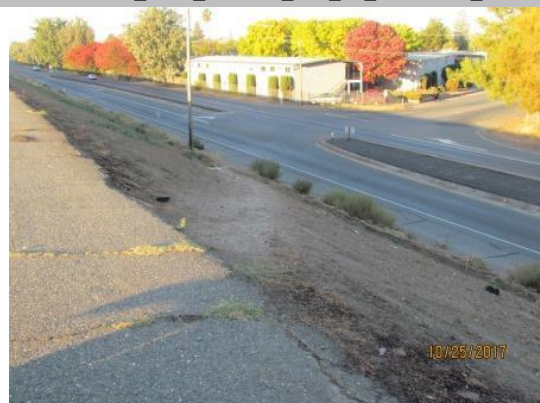
Photo 1 of 1 : SP_2018_NA0004_106_40_20180302_00016.jpg

View looking downstream landside of foot path that is cut into the landside levee slope, Fall 2017.

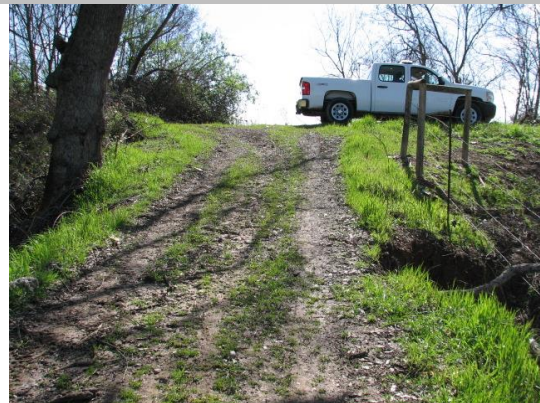
Photo 1 of 1 : SP_2018_NA0004_106_10_20180302_00005.jpg

This ramp is on the patrol road, no known permit.
